# A P-3C Flap Delivers a Knockout Punch

By AM2 Greg Tucker

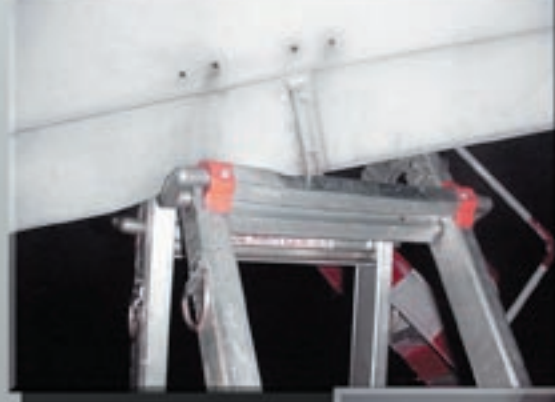
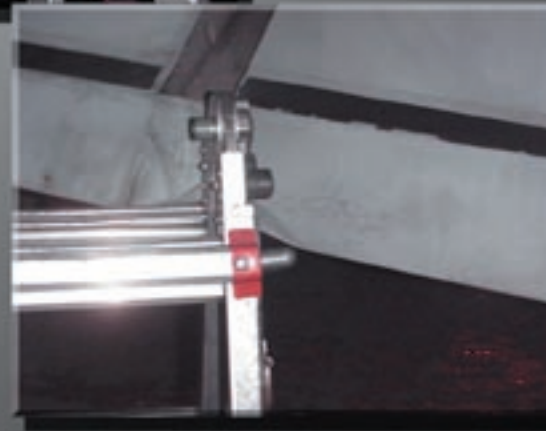
Both views of this flap crunch are necessary to gauge the damage.

noticed the inboard trailing edge of the port flap had extended down onto the ladder, creating a 3-inch-by-3-inch rip in the trailing edge. At first, I had hoped this was just a terrible nightmare; however, reality quickly set in, and I knew the aircraft had been damaged.

After a thorough inspection and investigation, it turned out the damage was minimal, requiring only 12 maintenance hours to repair the tear. The flap strike had missed a flap rib by a mere 7 inches! Had the ladder hit this rib, a Class C mishap would have resulted.

Our squadron's SOPs are clear regarding wing-flap extension. Three people are required during the evolution, and my job was to make sure the flap-extension danger area was clear of any gear. I failed to spot the ladder, and this incident served as a valuable reminder to my squadron and shipmates that complacency can strike in any operating environment, no matter how mundane or routine a task might seem.
